AFRL-ML-TY-TP-2004-4516

POST-FIRE DAMAGE ASSESSMENT OF A COMPOSITE WINGBOX

May 2004

THIS TECHNICAL PAPER HAS BEEN REVIEWED AND IS APPROVED FOR PUBLICATION. IT WAS PRESENTED AT THE 2004 SAMPE CONFERENCE, LONG BEACH, CALIFORNIA; 16-20 MAY 2004.

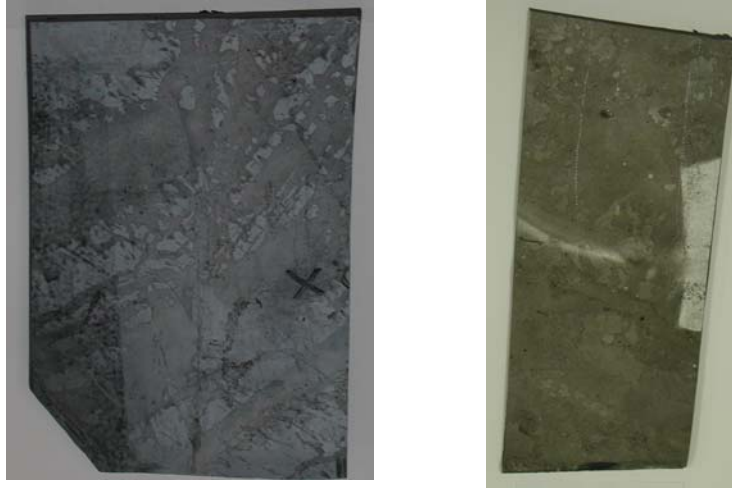
Photographs of some of the samples are shown below. One minute exposure samples show varying degrees of damage ranging from surface discoloration to scorching and pitting. This may be due to the coating on the composite material (paint or others) burning away. All the 5 minute exposure samples (top and bottom of wing box) show significantly more damage than the 1 minute samples, as expected. In most cases, the 5 minute samples were essentially completely

Figure 1 Photographs of two samples (1W-T-6, 1W-T-1) from top-side of Wing Box 1 (1 minute exposure)

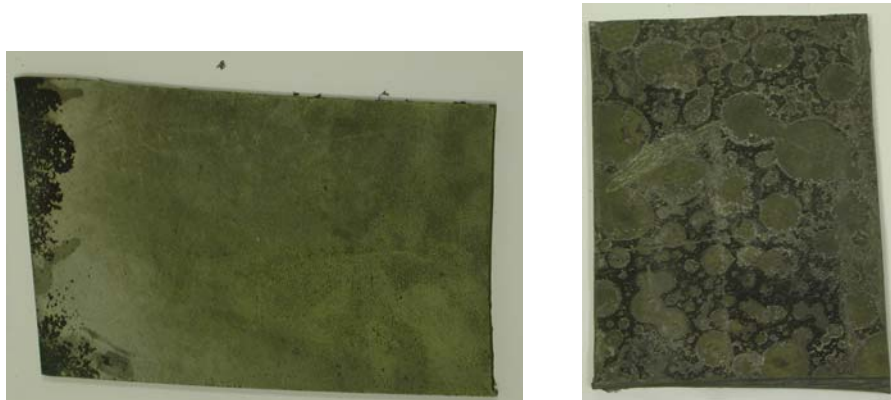
Figure 2 Photographs of two samples (1W-B-1, 1W-B-3) from bottom-side of Wing Box 1 (1 minute exposure)

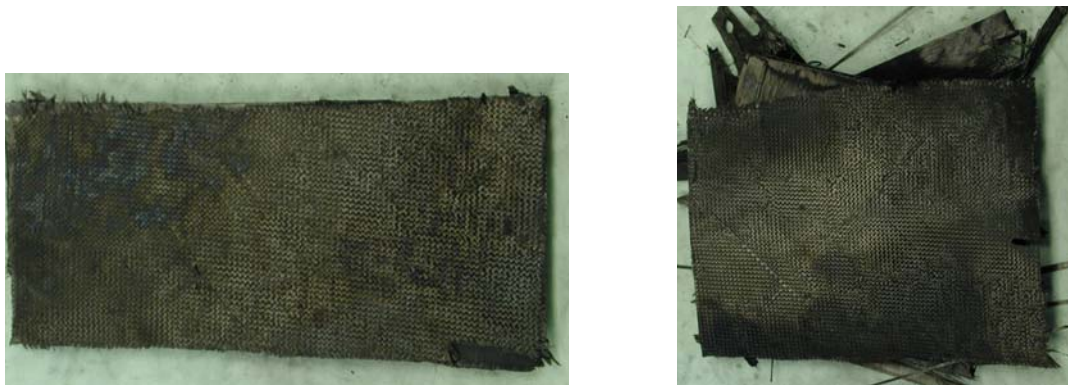
damaged to the point where property measurements would be impossible. These samples showed very visible resin loss, fiber damage and layer separation (Figures 3 and 4). We can also expect some fiber oxidation and burn damage due to the temperatures measured during the 5 minute burn test.

Figure 3 Photographs of two samples (2W-T-6, 2W-T-1) from bottom-side of Wing Box 2 (5 minute exposure)

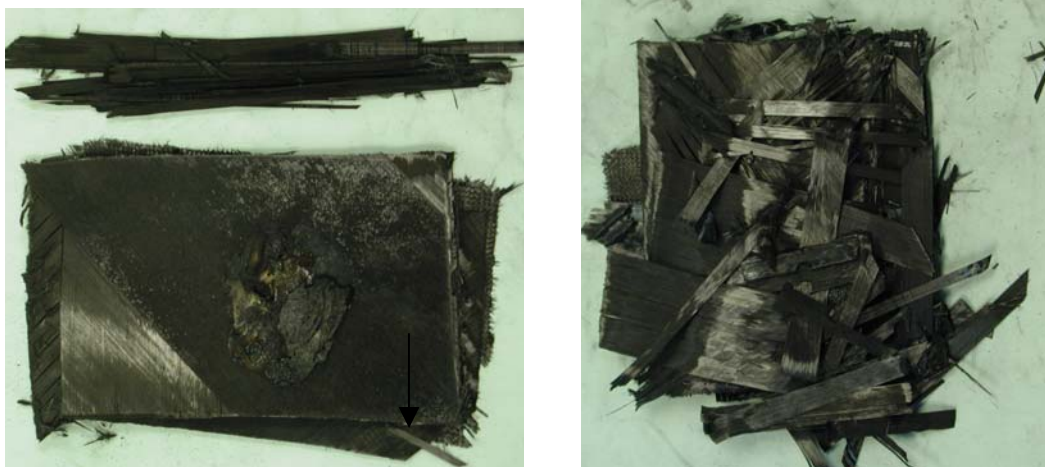
Figure 4 Photographs of two samples (2W-B-1, 2W-B-2) from bottom-side of Wing Box 2 (5 minute exposure)

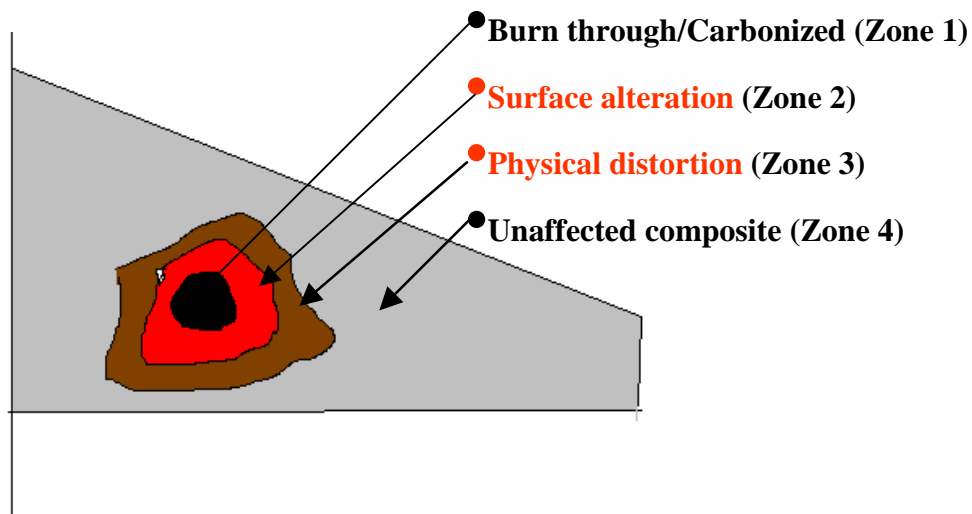
Figure 9: Schematic of typical burn zones due to fire damage

Based on the property assessments in the wing box samples, fire damage can generally be classified into four zones as shown schematically in Figure 9, irrespective of thermal history.

- Zone 1-Complete carbonization/burn through

Wing box 2 (entire 2W-B series samples and most 2W-T)

Maximum damage occurs at the area exposed to the highest thermal exposure (Zone 1) and can be severe – burn through and carbonization of the fibers. This zone will also

show the maximum weight loss (up to 100%) depending on the severity of damage. Performance assessment of this zone will be limited to visual inspection, weight loss and density change as any other assessment is essentially meaningless.

- Zone 2- Surface oxidation/chemical alteration

Wing box 2 (2W-T-3, 2W-T-6)

This zone will show significant alteration in chemical structure of the material due to degradation kinetics. Weight loss in this zone may be significant and can contribute to large-scale property degradation. Damage assessment in this zone will involve visual, weight loss and density measurements, followed by thermo-mechanical property evaluation to understand degradation kinetics of the material.

- Zone 3- Mechanical distortion due to heat

Most of Wing box 1 (1W-B samples and some 1W-T)

This zone may have some visual damage due to exposure of heat (especially paint, coatings etc) and mechanical distortion of the composite may occur that ultimately changes the performance. Parameters that will be used for damage appraisal of this zone include Tg change, Density /Volume change, Surface characterization and NDE for internal damage.

This is a critical zone as it delineates unrepairable material from that which can be repaired to restore mechanical performance.

- Zone 4- Undamaged material

Some of Wing box 1 (some 1W-T samples)

This zone represents material that has not seen degradation level temperatures (thermal history stays below at or below Tg), though some post-curing effect may be evident depending on the resin system. Thermo-mechanical properties are not expected to vary significantly from the baseline composite material.
